Seismic Methods Used To Check Strength of Concrete Runway Reconstruction

**Dean Rue, P.E.
CH2M HILL**

**2010 FAA Airport Technology Transfer
Conference**

**Atlantic City, NJ
April 20 - 22, 2010**

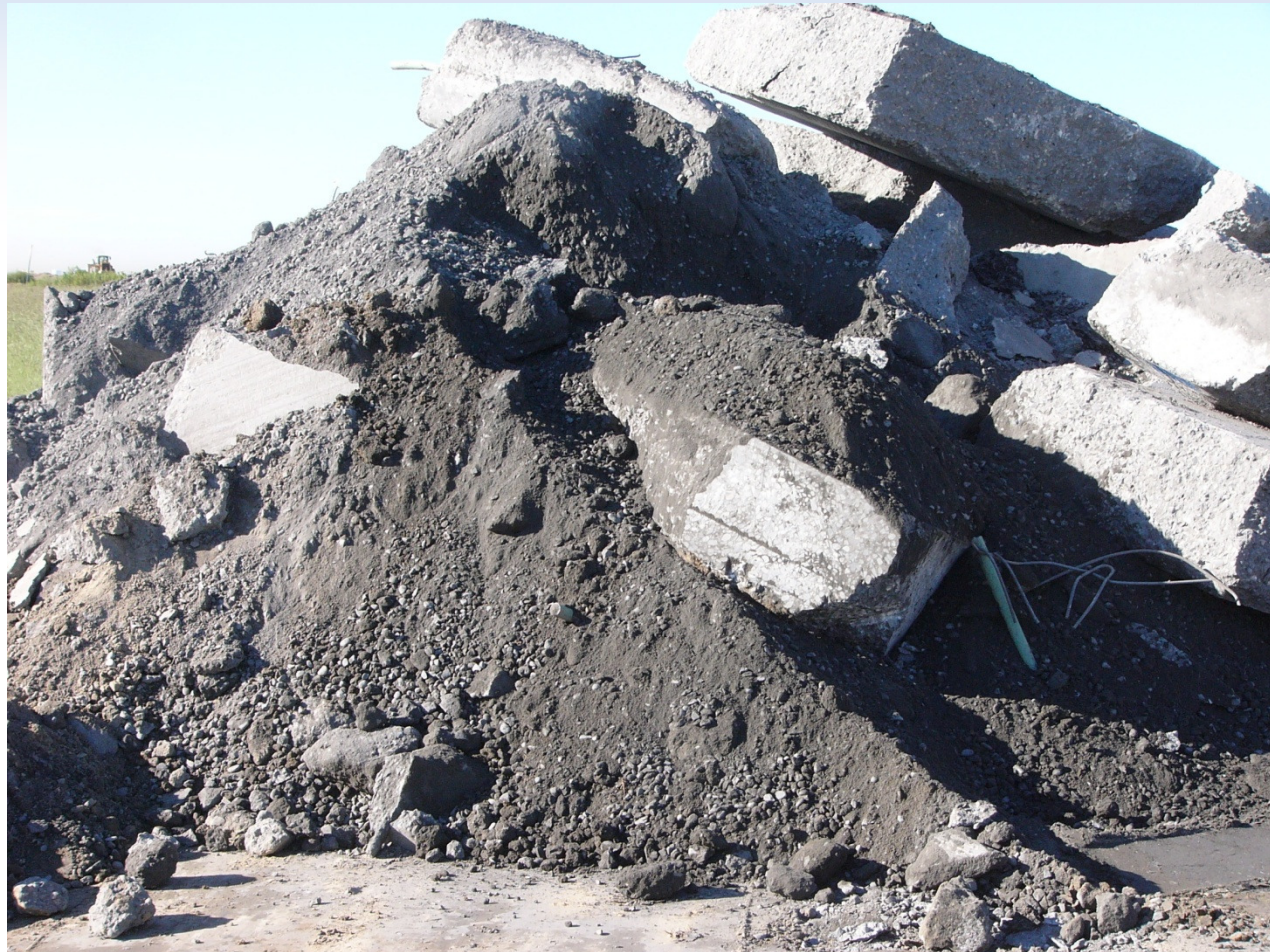
- **During construction, concrete appearance changed**
- **Very dark color and no typical concrete smell**
- **Contractor continued paving that day**
- **Next day, joint sawing spalled badly, core collapsed**
- **Paving stopped until problem identified and corrected**

Problem Concrete Removed

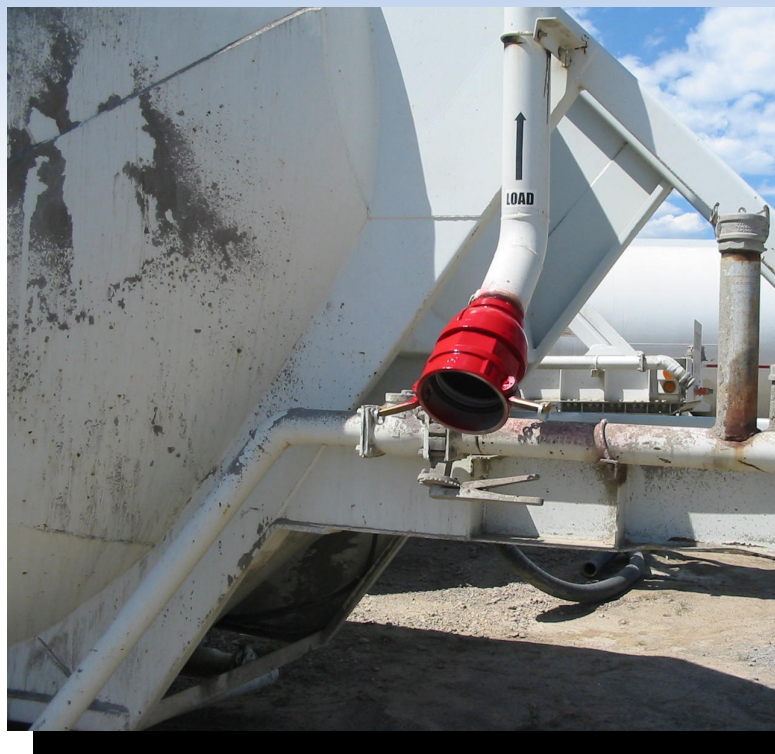
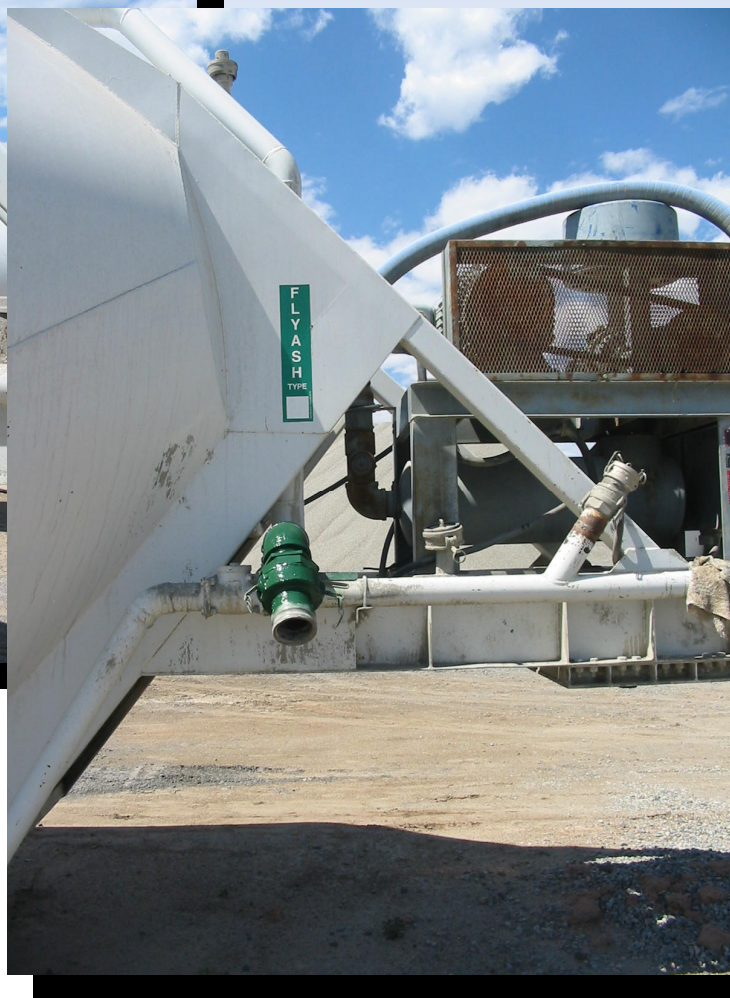
- **Quickly determined excess fly ash in mix**
- **Cement silo had fly ash in it, was emptied**
- **Contractor investigated found SAME leased trucks used for cement and fly ash, weren't cleaned out**
- **Started paving again**
- **Problem happened again within 2 weeks**
- **Contractor installed colored flanges to silos**
- **Truck driver had to check out proper flange from superintendent to unload**

Colored Flanges

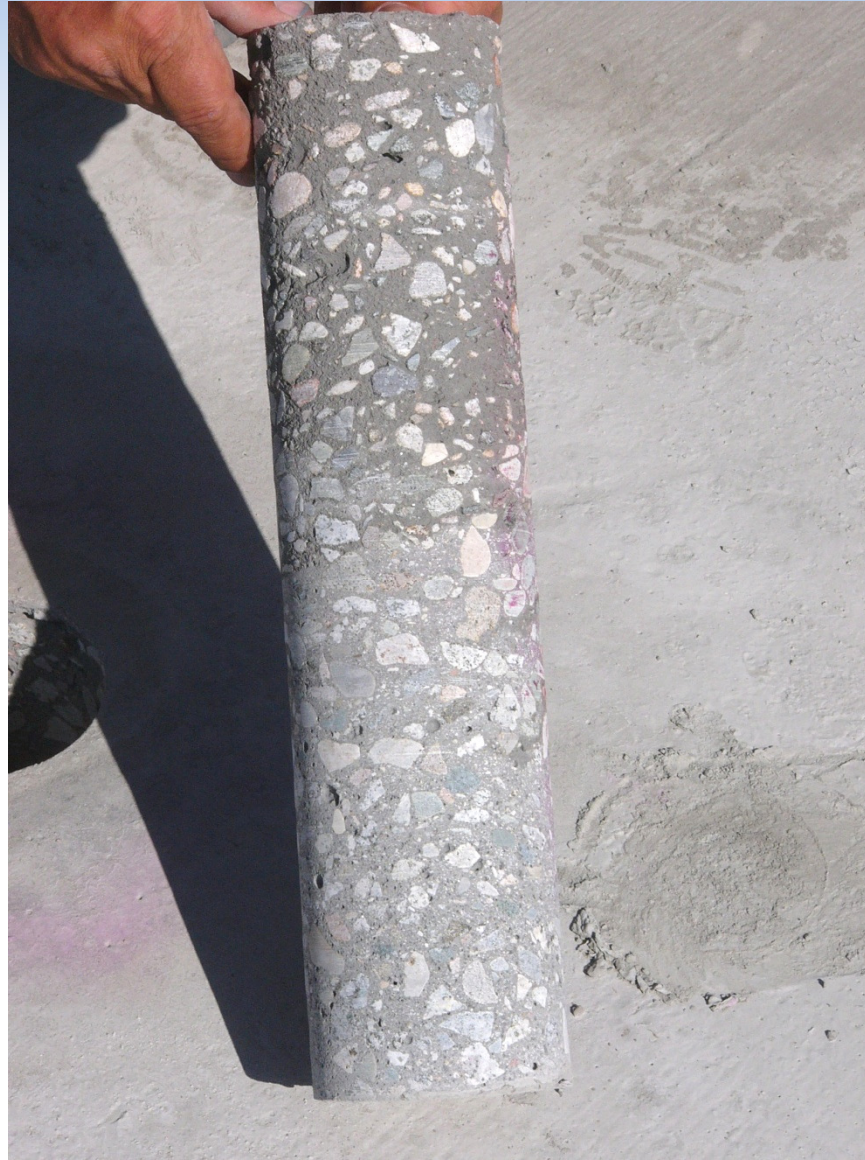
- **PCC removed that was clearly visually contaminated**
- **Difficult to identify the exact location of start of contamination**
- **Removal progressed all directions until visually “sound” PCC found**
- **Contractor immediately replaced all of the removed PCC**
- **Lingering doubts if PCC left contained more that 30% fly ash in mix design**

Concrete Core, Top Excess Fly Ash

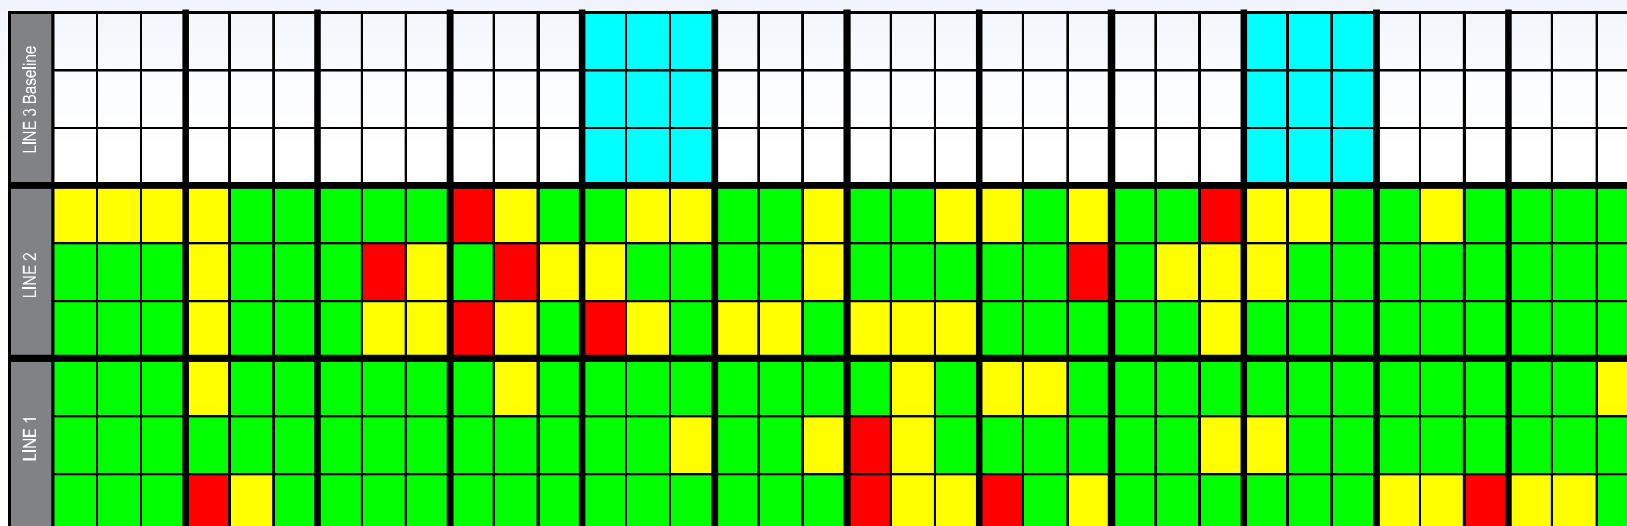
Sublot 27-4

Total	24
Red	9
Yellow	12

216
12
52

- **Accept PSPA results of adequate strength for 9 of the 11 sublots (not 27-4 and 29-3)**
- **Accept Petrographic results for Sublots 27-4 and 29-3 and verified 28-1 and 28-2 could remain**
- **Allowed all panels in the 11 sublots that were tested, to remain in-place**
- **Contractor received no payment for the 23 panels with 1 or more “red” test sites**

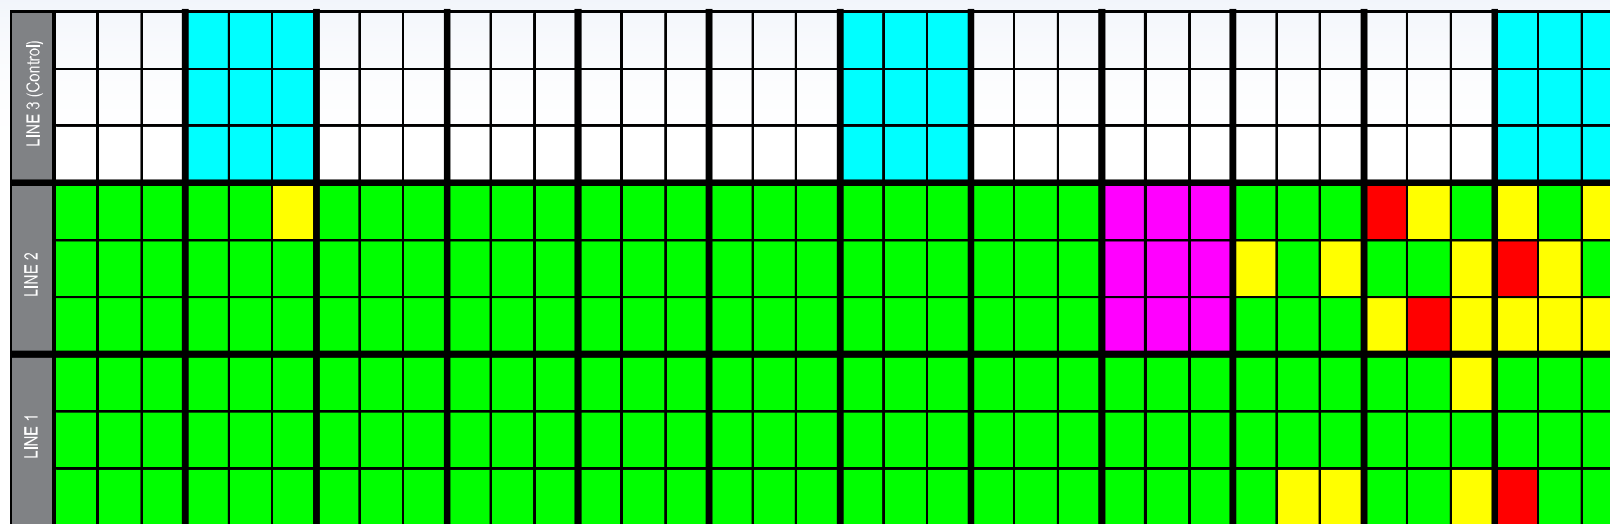
Sublot 28-1

Total	23
Red	3
Yellow	3

207
4
16

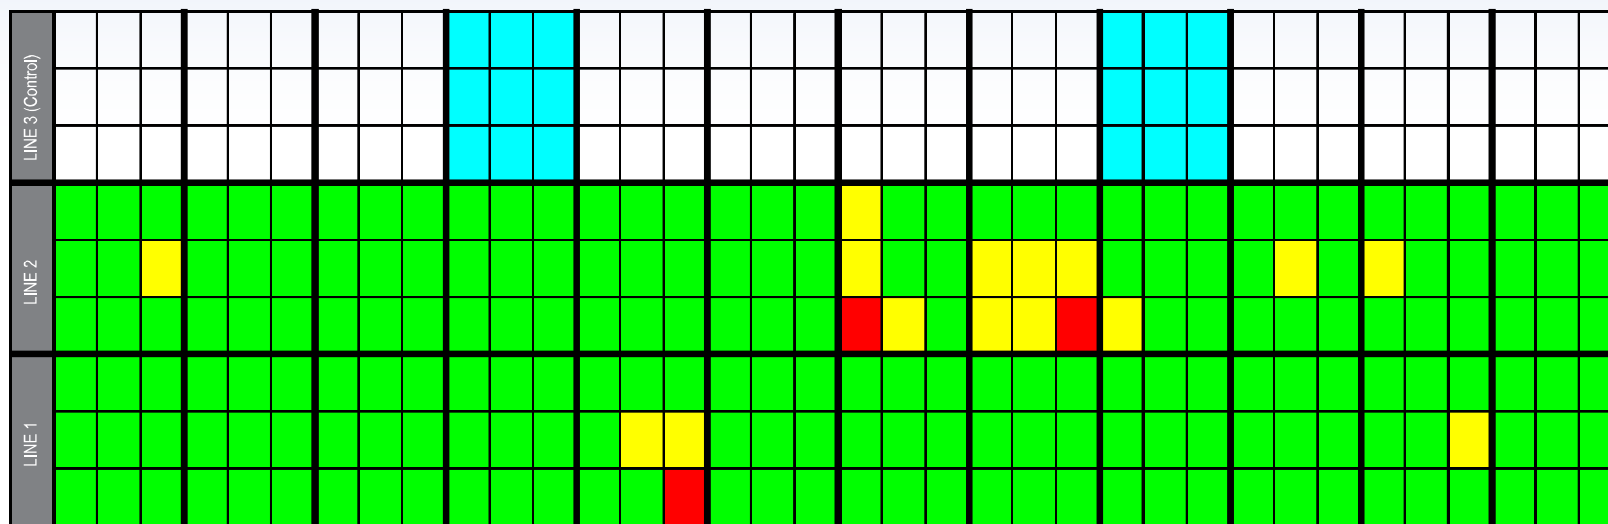
Sublot 28-2

Total	24
Red	3
Yellow	5

216
3
15

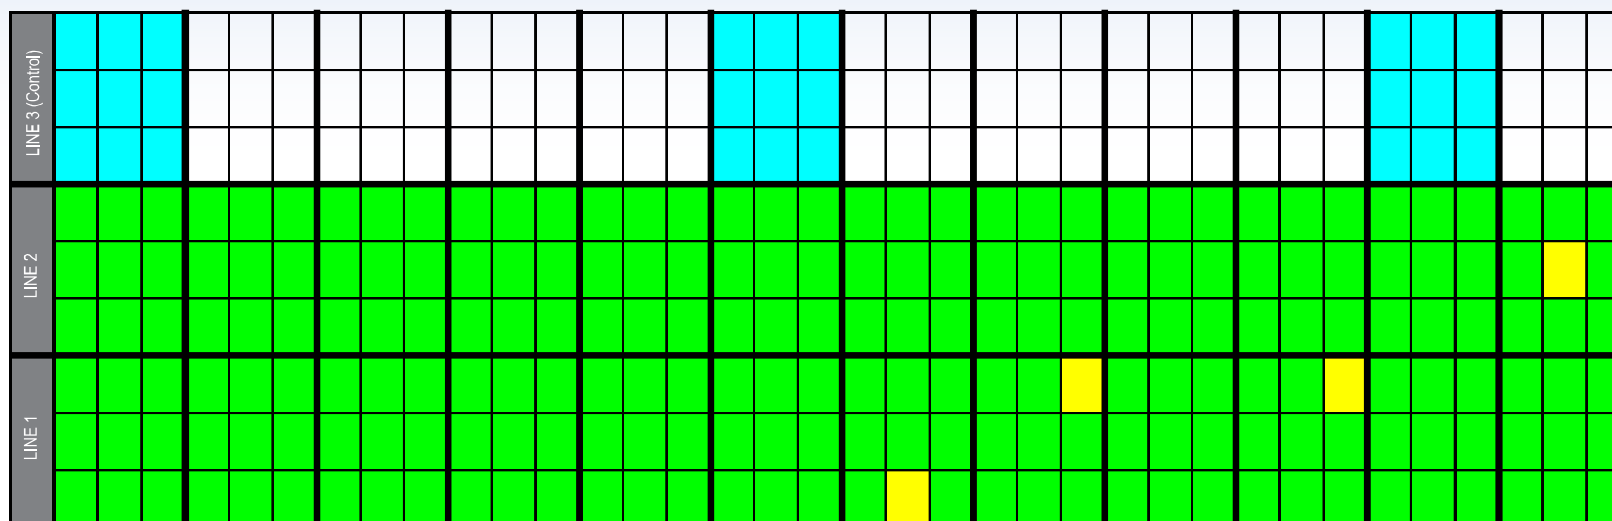
Sublot 28-3

Total	24
Red	0
Yellow	4

216
0
4

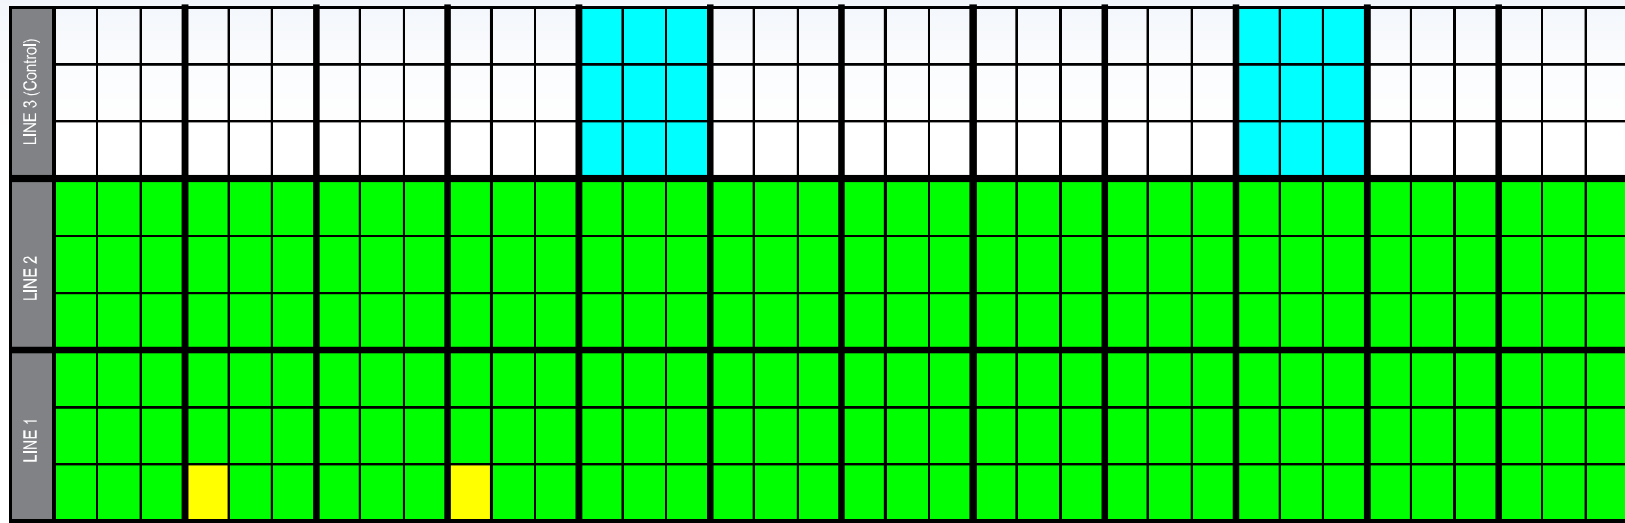
Sublot 29-1

Total	24
Red	0
Yellow	2

216
0
2

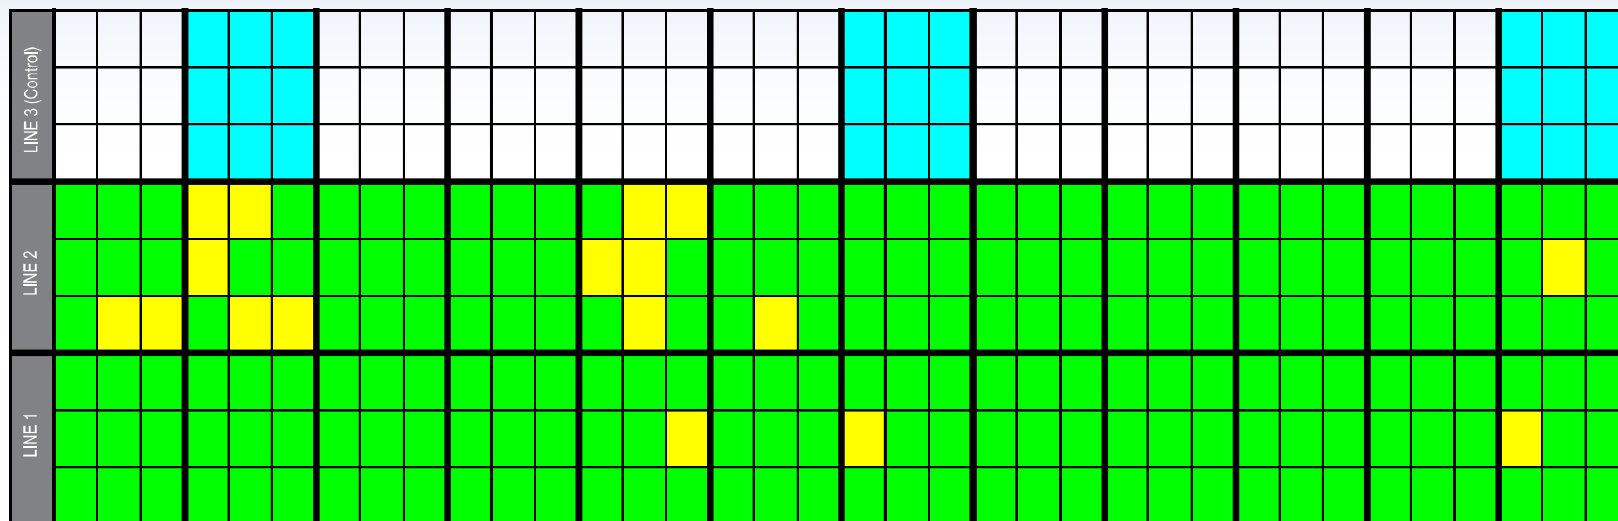
Sublot 29-2

Total	24
Red	0
Yellow	8

216
0
17

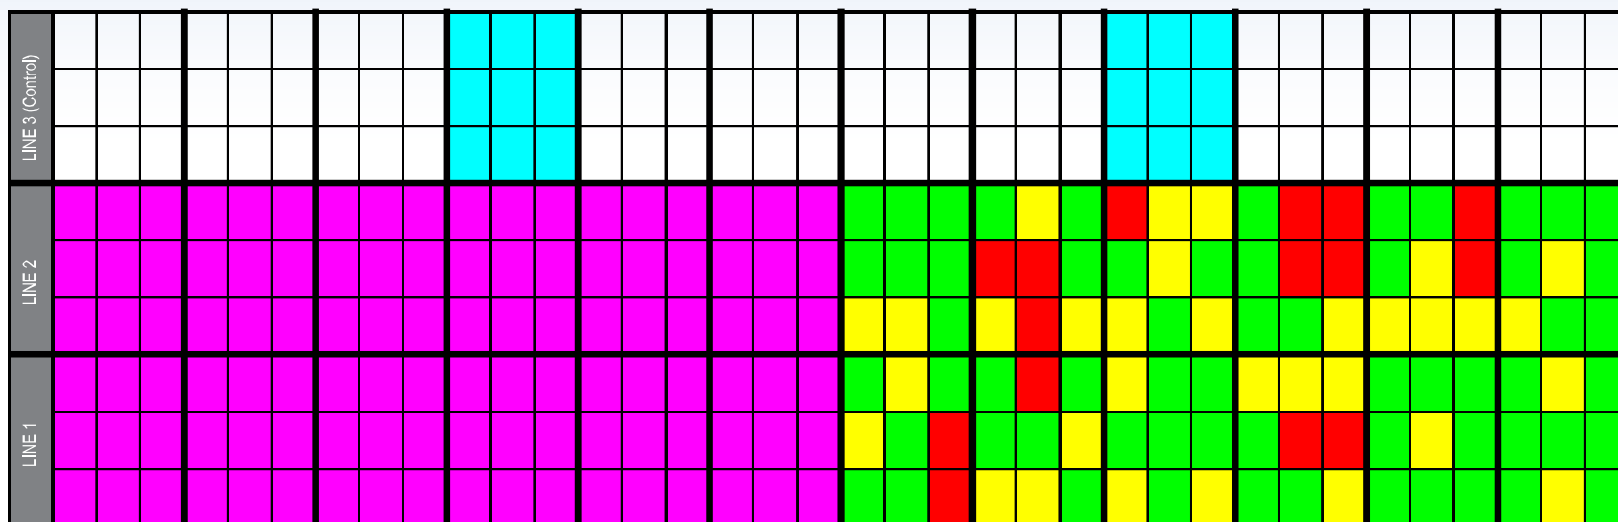
Sublot 29-3

Total	12
Red	7
Yellow	5

108
15
32

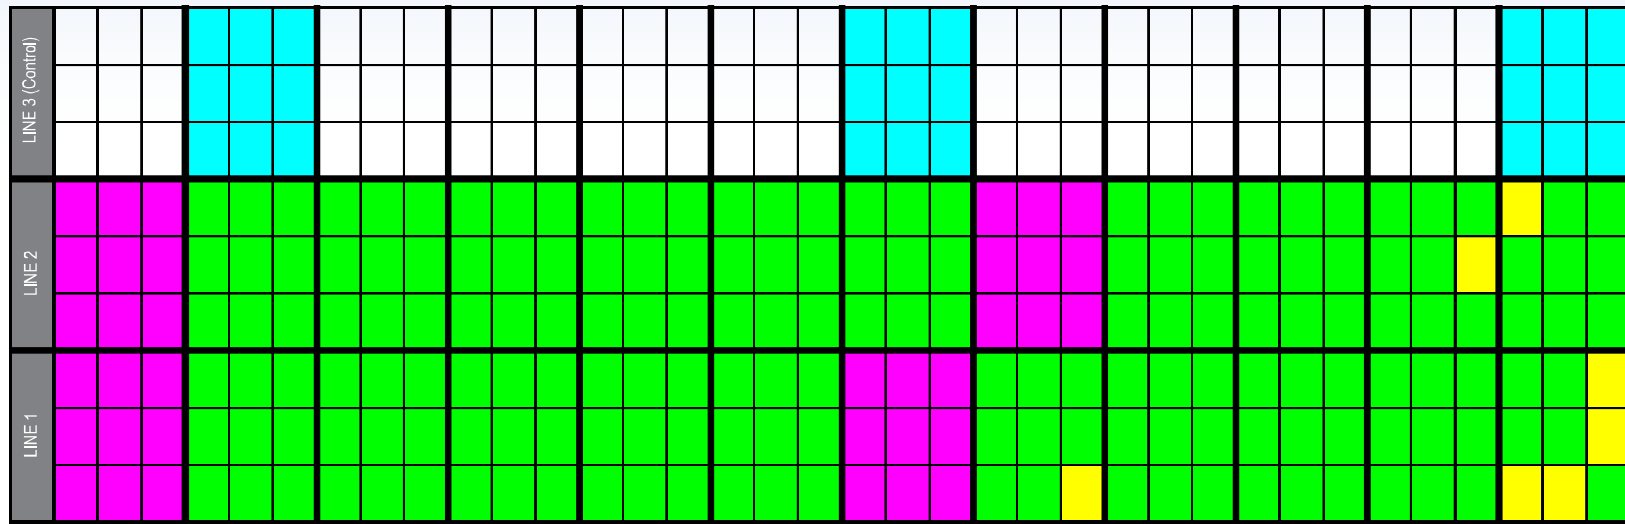
Sublot 31-1

Total	20
Red	0
Yellow	4

180
0
7

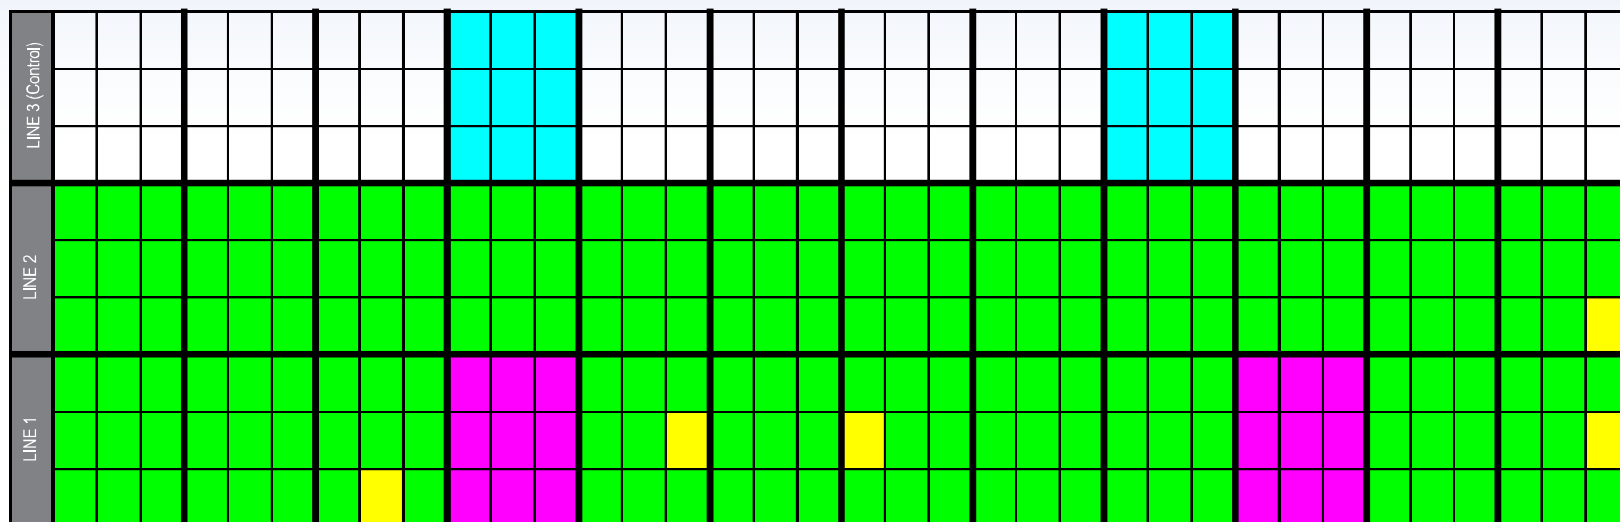
Sublot 31-2

Total	22
Red	0
Yellow	5

198
0
5

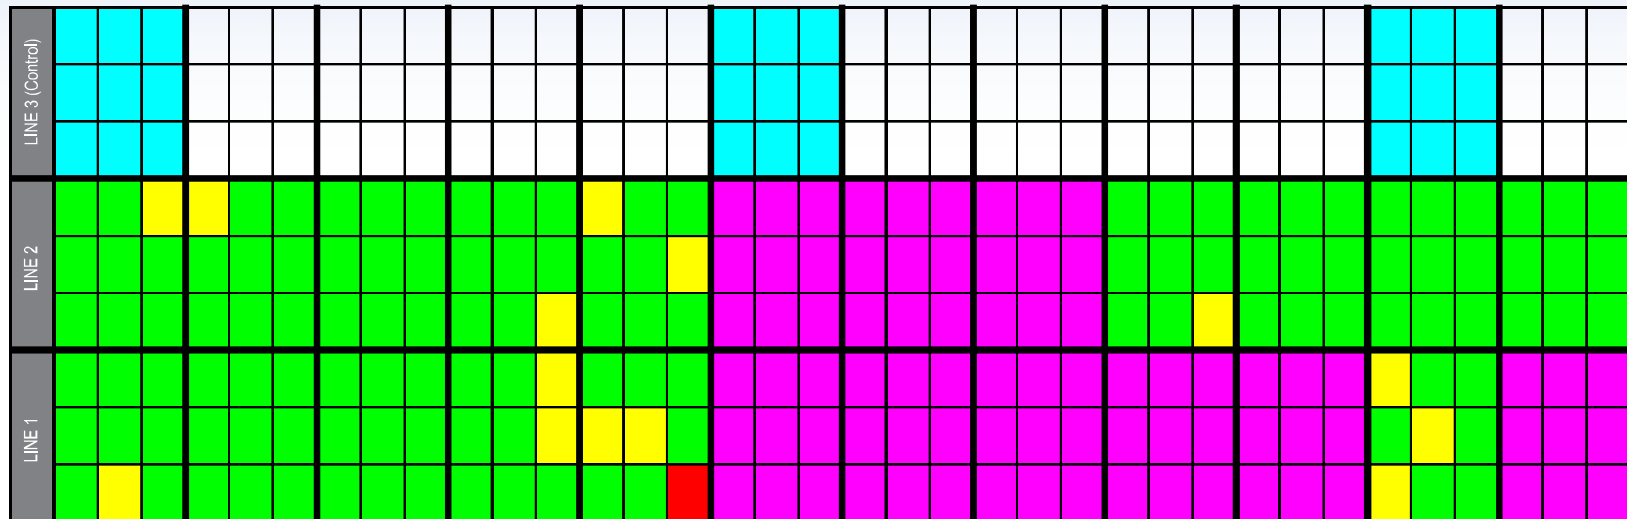
Sublot 31-3

Total	15
Red	1
Yellow	9

135
1
14
